**BRISTOL MILLS DAM FEASIBILITY STUDY
FOR THE
THE TOWN OF BRISTOL AND
BRISTOL DAM COMMITTEE**

JANUARY 2018

WRIGHT-PIERCE

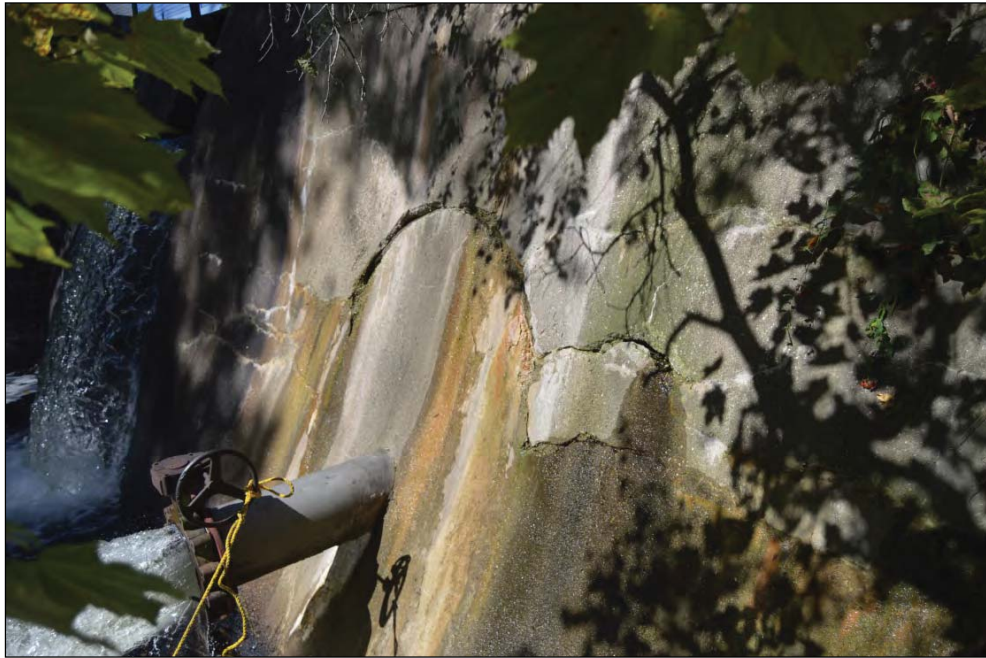
Photo # 16 – Cracks in Downstream Face Right Side

1. Repair the cracking on the downstream face by grouting the cracks
2. Fill the voids along the toe of the dam
3. Repair the spalled concrete areas along the upstream intake and sluiceway areas.

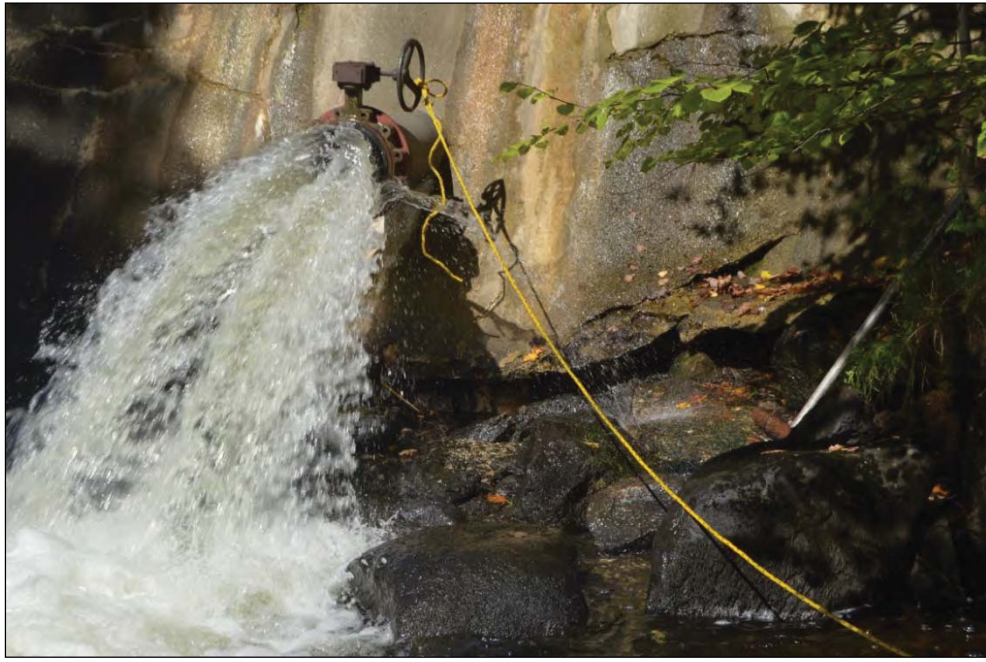
Photo # 17 – Voids at base of Downstream Abutment

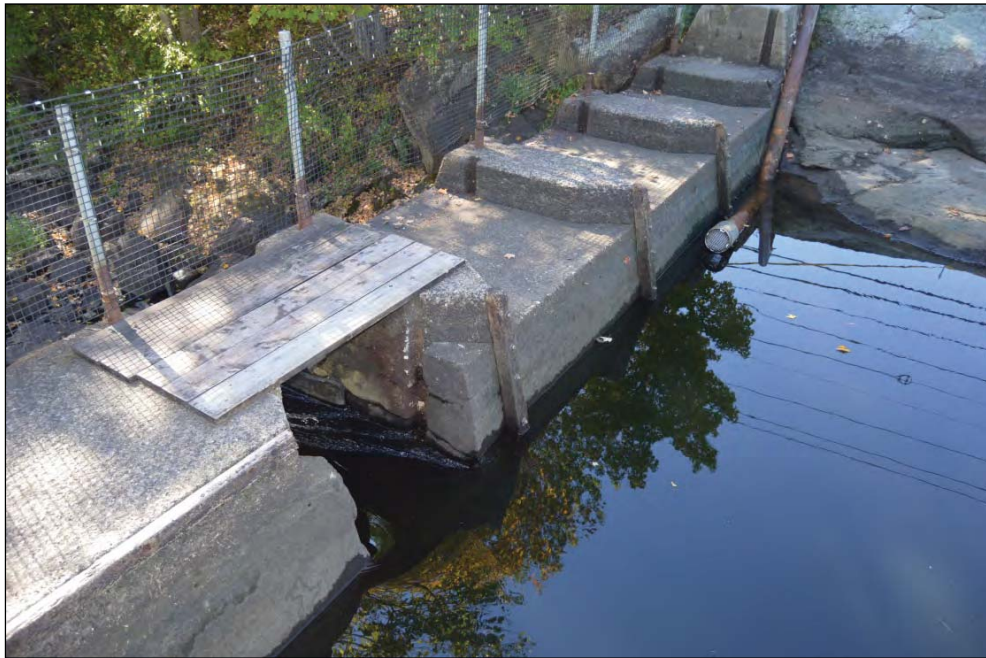
Photo #20 – Sluiceway with Concrete Cracking and Exposed Rocks

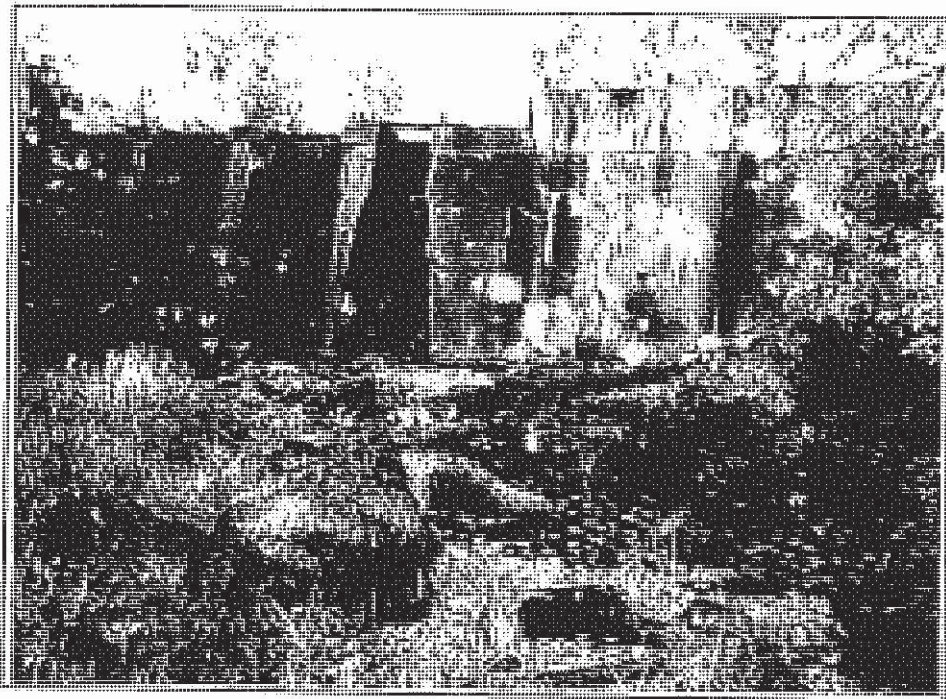
Photo B-2. Bristol Mills Dam.
Downstream face of spillway and old intake with outlet pipe. Note
cracks in intake gunite placed in 1994.

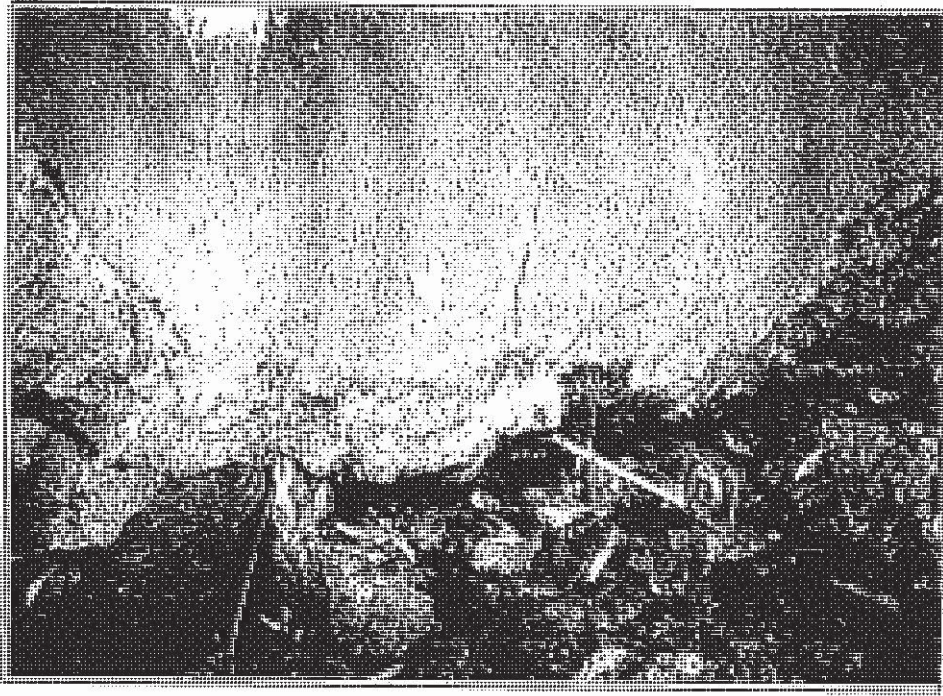
Photo B-3 Bristol Mills Dam.
Old intake. Note deterioration of 1994 gunite and seepage at base.

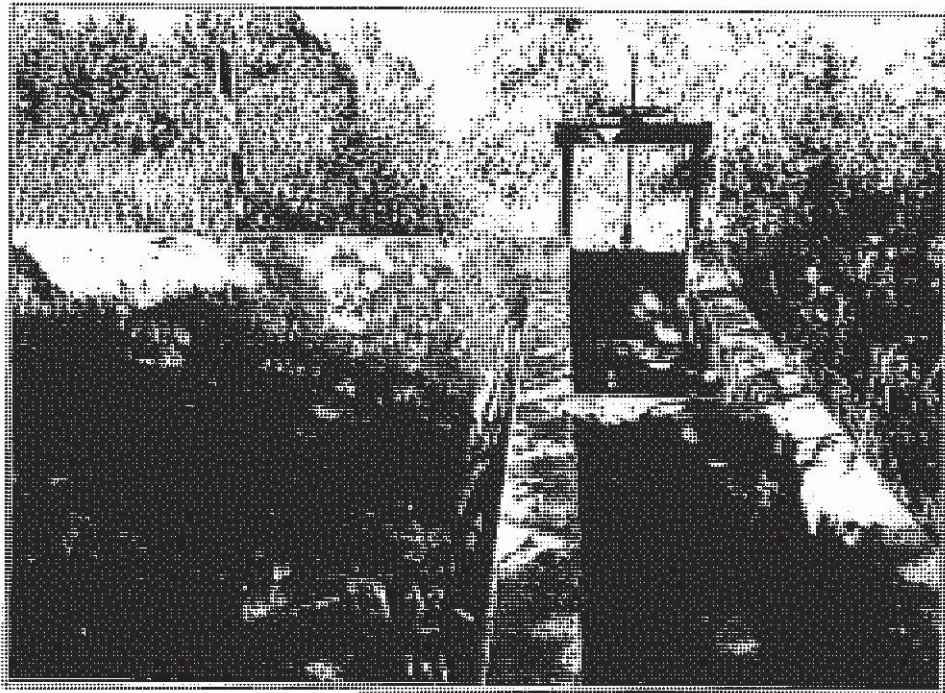
Photo B-4. Bristol Mills Dam.
East wall and fishway. Note crack on downstream face of east wall
and vegetation of east abutment.
