**BRISTOL MILLS DAM FEASIBILITY STUDY
FOR THE
THE TOWN OF BRISTOL AND
BRISTOL DAM COMMITTEE**

JANUARY 2018

WRIGHT-PIERCE

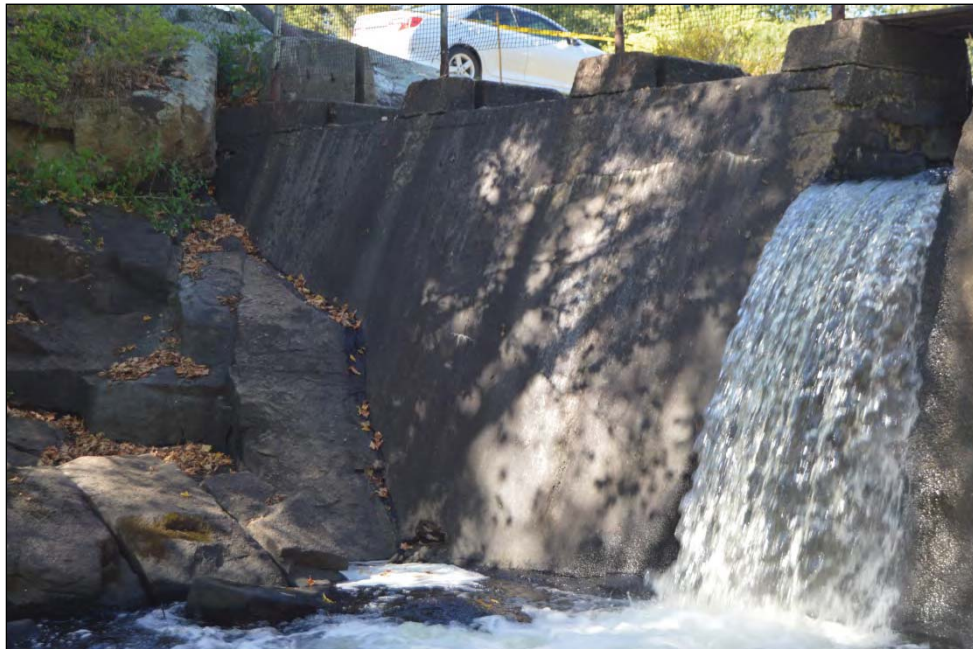
Photo #3 – Overview of Left Abutment
