**BRISTOL MILLS DAM FEASIBILITY STUDY
FOR THE
THE TOWN OF BRISTOL AND
BRISTOL DAM COMMITTEE**

JANUARY 2018

WRIGHT-PIERCE

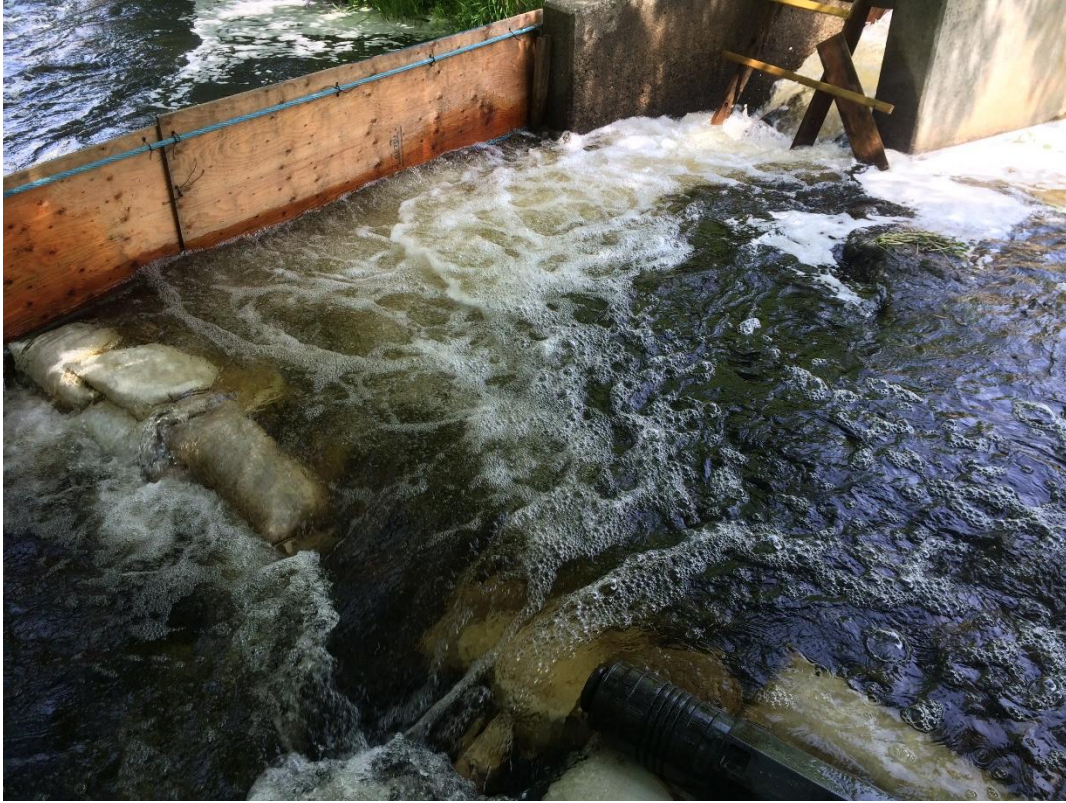
It is important to note that the fishway was being operated with a number of “improvements” devised by the Town of Bristol Fish committee. This includes the use of a leader fence, as well as a sandbag wier and wooden chute at the fishway entrance. At the upstream end of the fishway (exit) there was a wooden baffle with an orifice being utilized to reduce flow in the fishway. Photos of these entrance and exit conditions are included on the following pages.

Photo 1: Fishway Entrance during PIT Tag Study

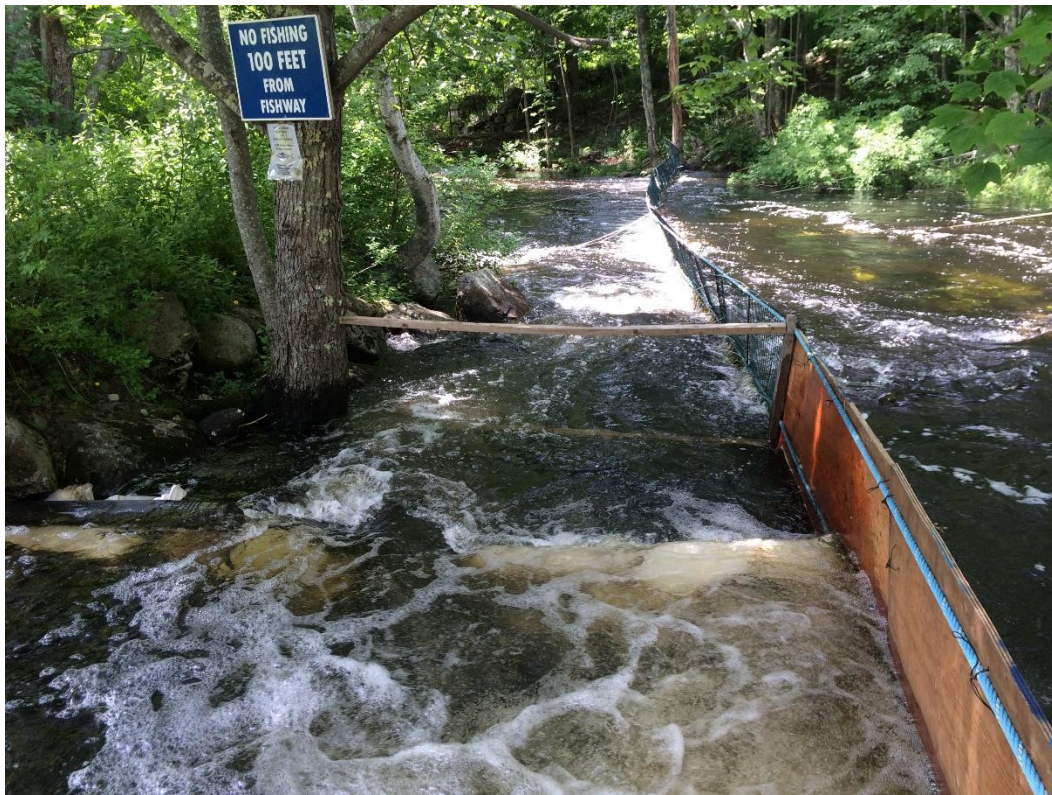
Photo 2: Fishway Entrance during PIT Tag Study

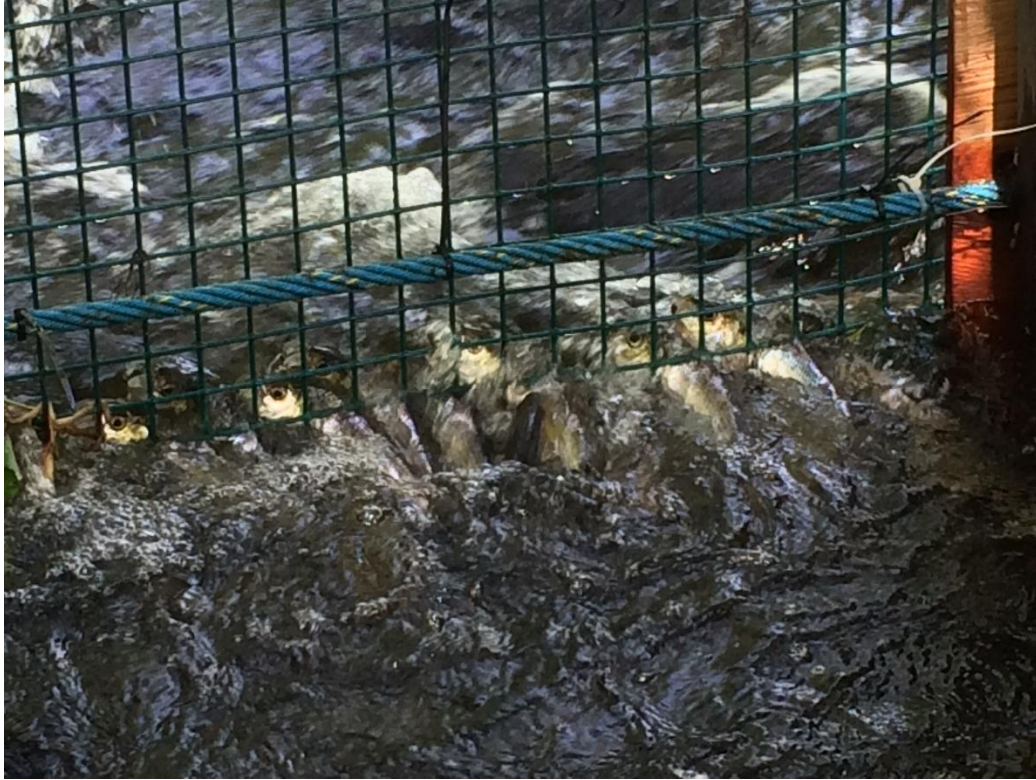
Photo 3: Dead Alewife in leader fence (trying to get upstream)

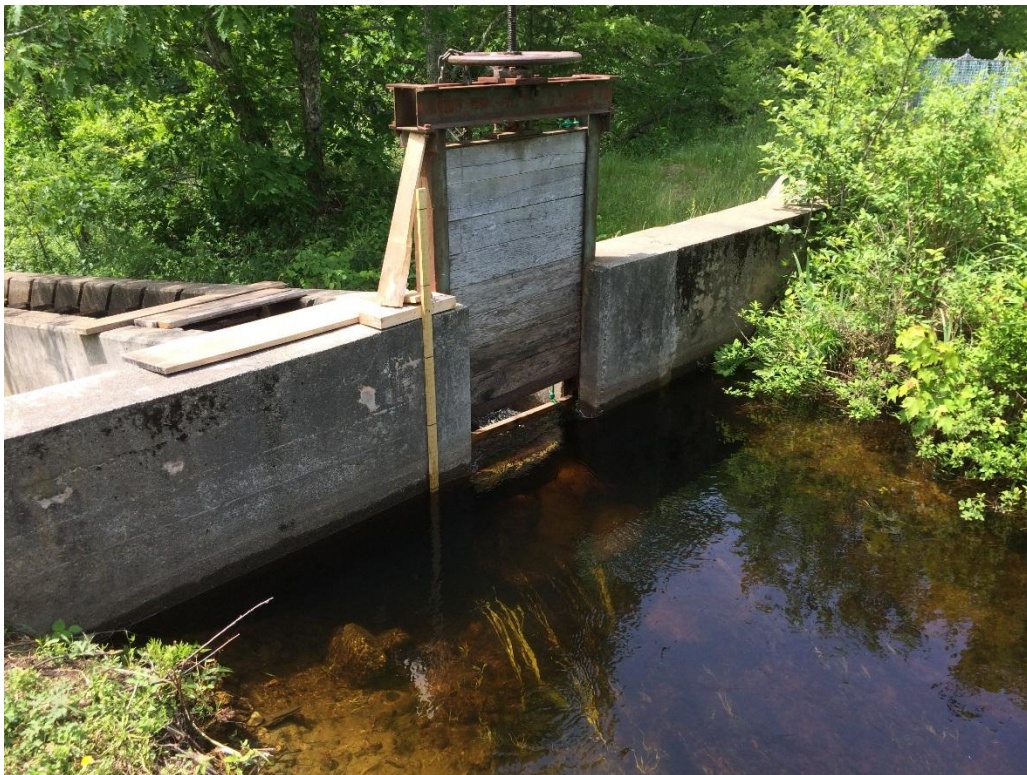
Photo 4: Fishway Exit during PIT Tag Study

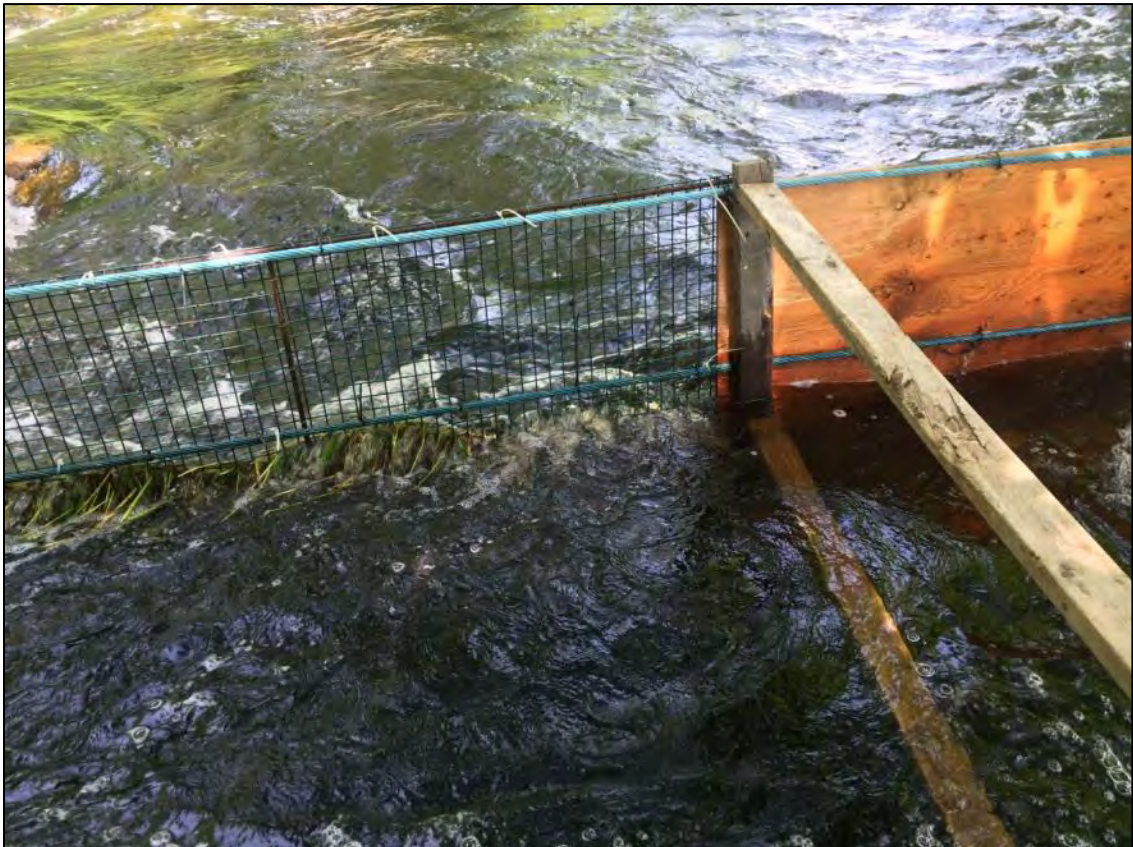
Photo 16 – 6/17/14.

Alewives are not adequately attracted to the entrance of the fishway: The existing fishway entrance is located approximately 80 feet downstream of the dam and associated spillway discharge. During verbal interviews with the Town of Bristol alewife committee volunteers, there were a variety of accounts of substantial numbers of alewife bypassing the fishway entrance and collecting in the pool located just downstream of the Bristol Mills Dam. To address this concern, the Alewife committee deploys a mesh leader fence during each passage season (refer to photo 19 in appendix A). This leader fence spans the entire width of the river and is angled slightly upstream to provide a “funneling” effect that directs migrating adults to the fishway entrance. The precise construction of the leader fence has evolved over the years to its current configuration. While the fence appears to be reasonably effective, flow through the fence continues to prove to be attractive to the migrating fish and numbers of the alewife attempt to find their way through. There are a certain percentage of migrating adults that make their way past the fence and to the upstream pool area. In some cases, these bypass attempts fail and result in increased mortality as evidenced by the deceased alewife that collect in the fence mesh (refer to photos 16 and 17 in Appendix A).

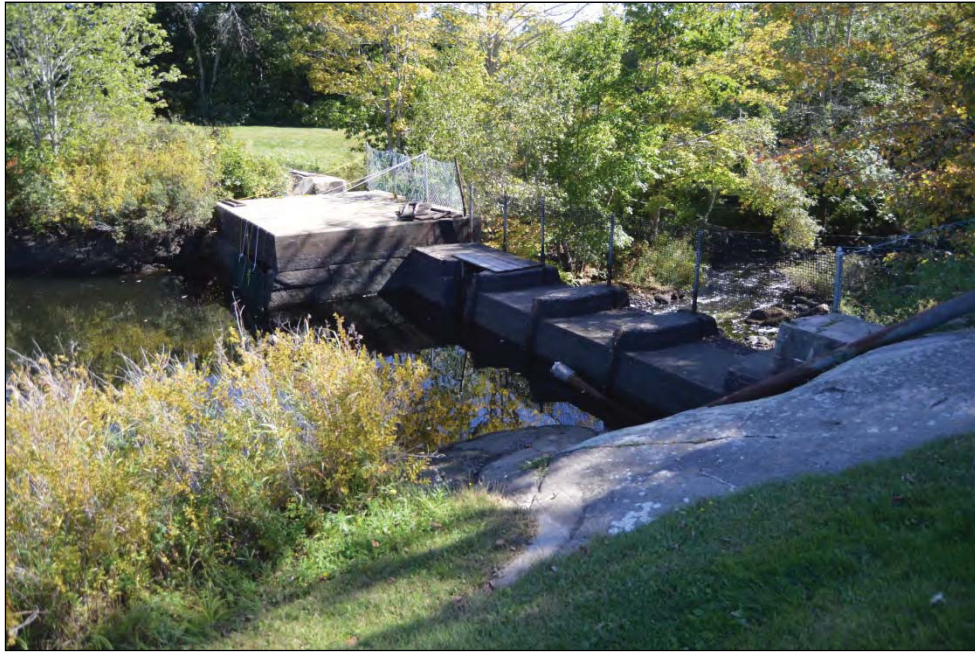
Photo #1 - Overview of Dam from Upstream

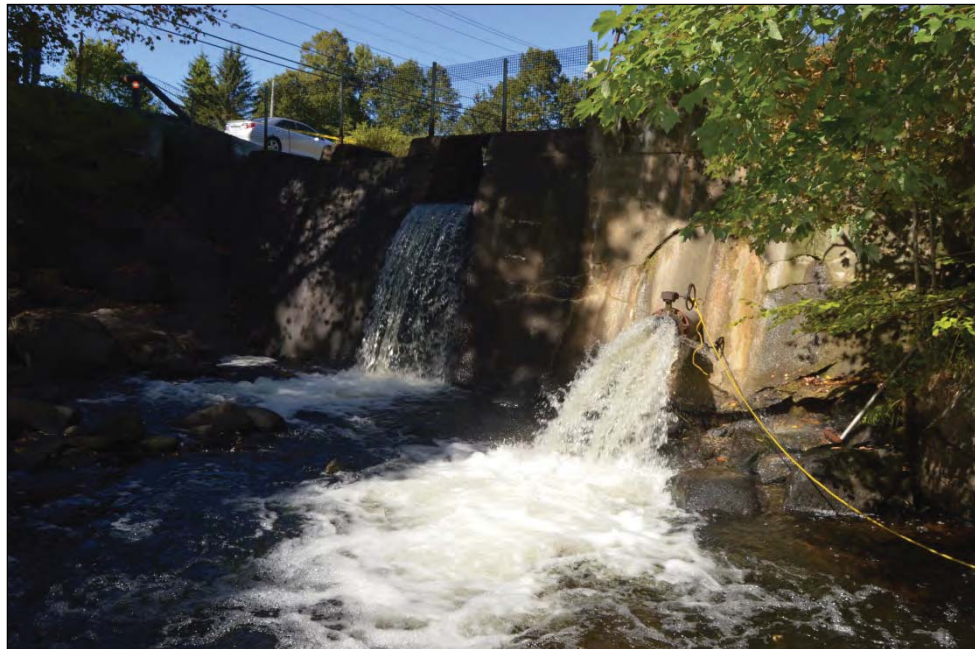
Photo #2 – Overview of Dam from Downstream

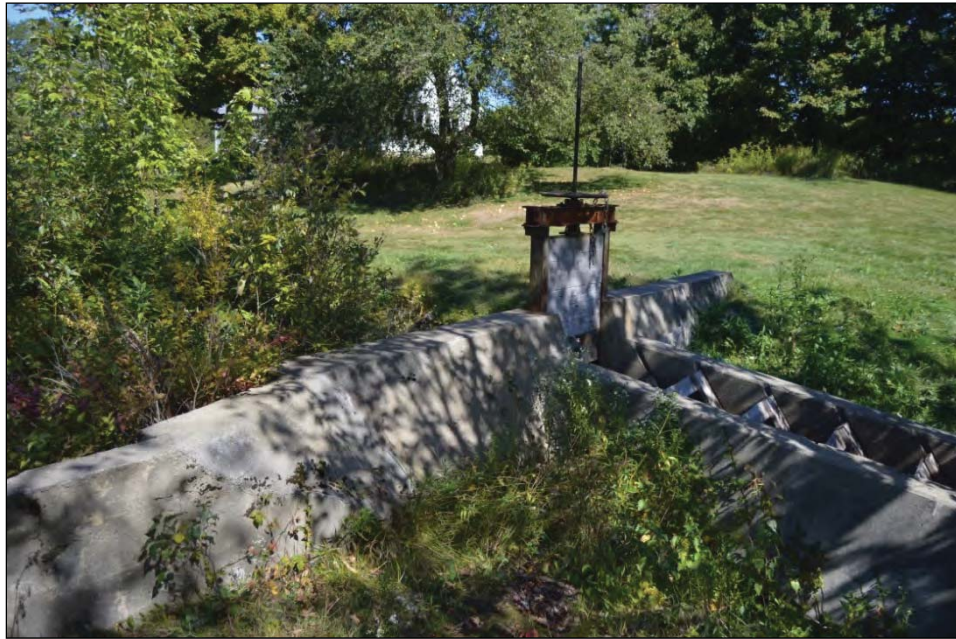
Photo #3 – Overview of Left Abutment

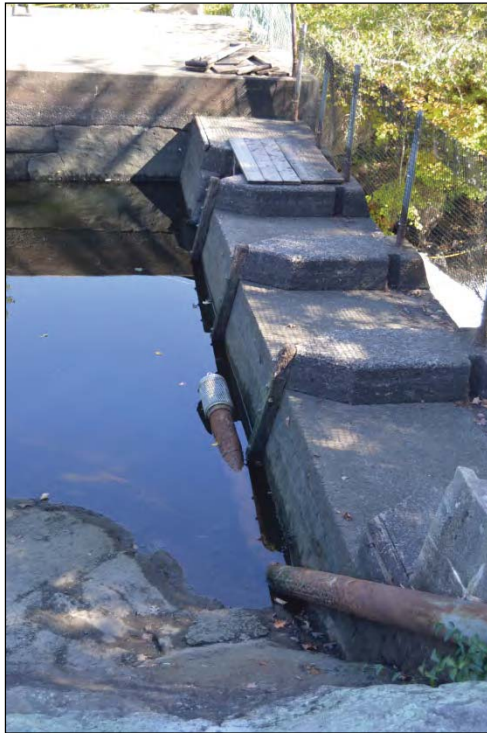
Photo #4 - Overview of Downstream Face Right Abutment

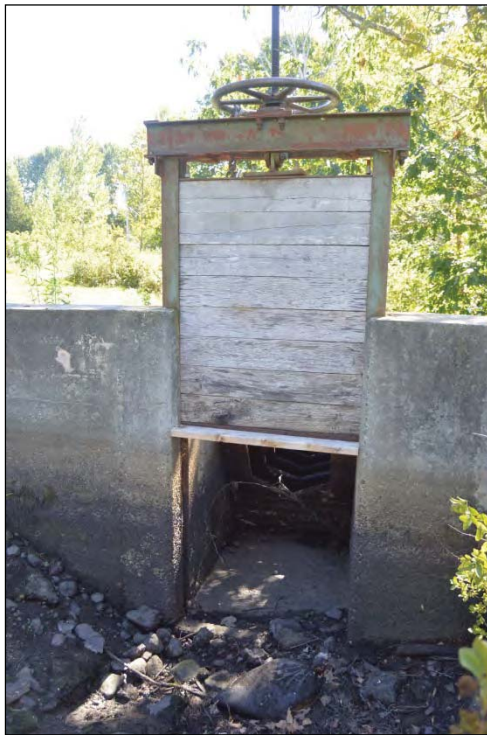
Photo #5 – Overview Upstream of Spillway Crest

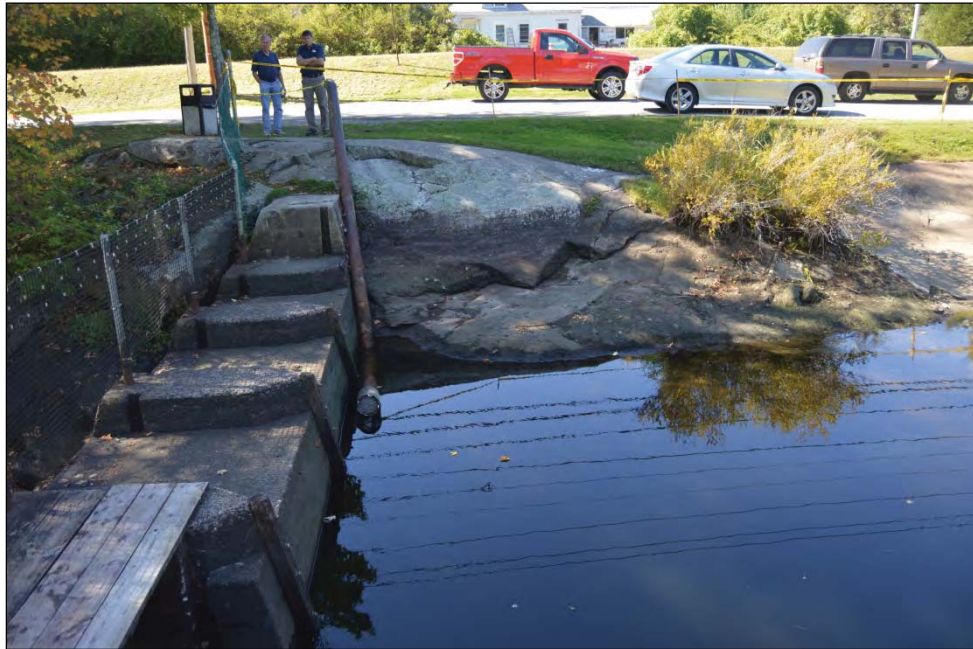
Photo # 6 – Fishway Control Gate on Left Abutment

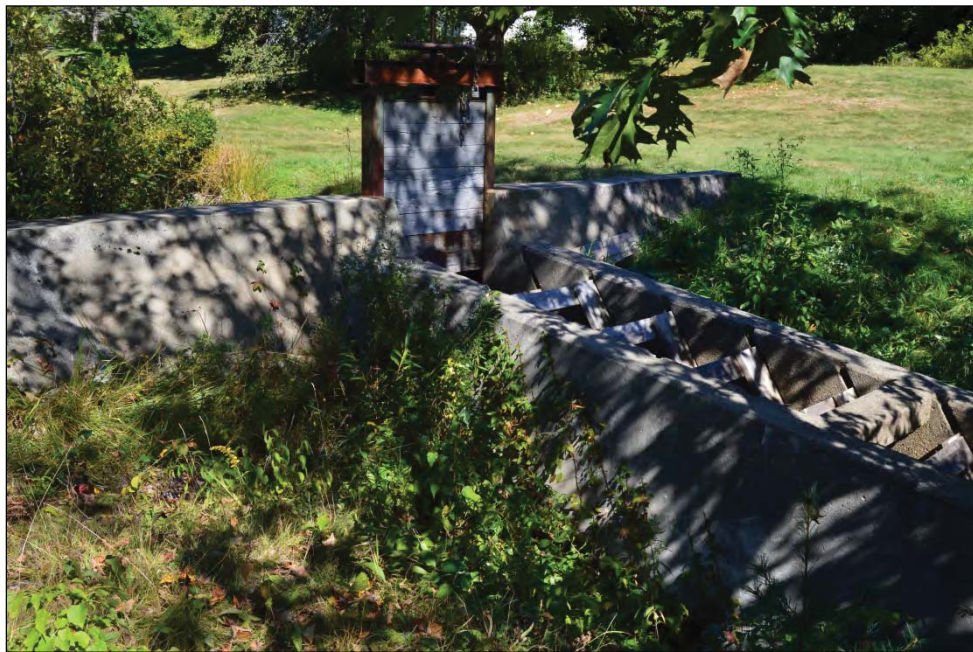
Photo #7 – Overview Upstream Face Right Abutment

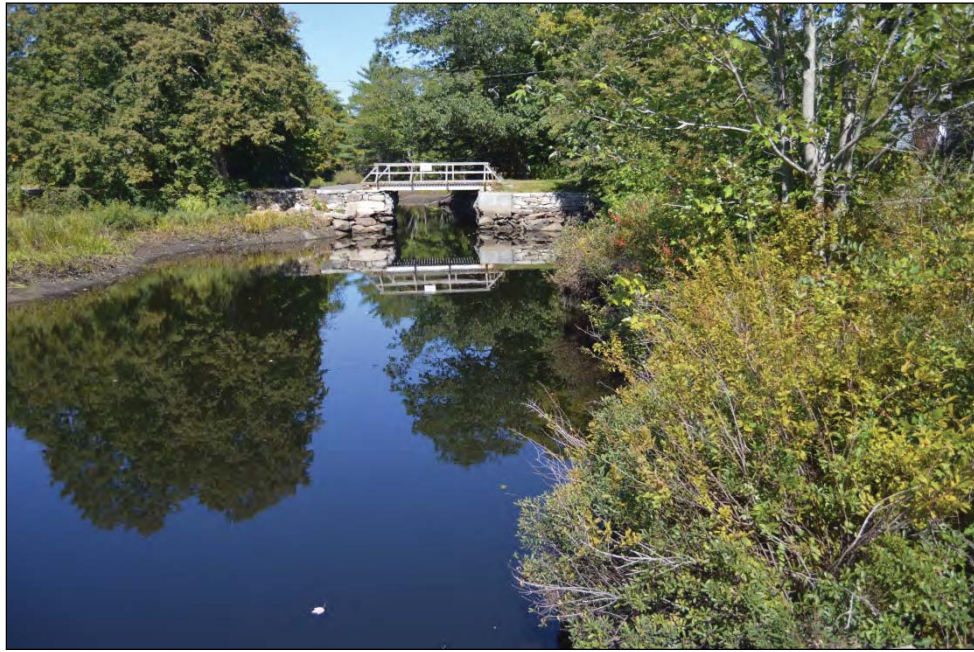
Photo #8 - Downstream Face Left Abutment

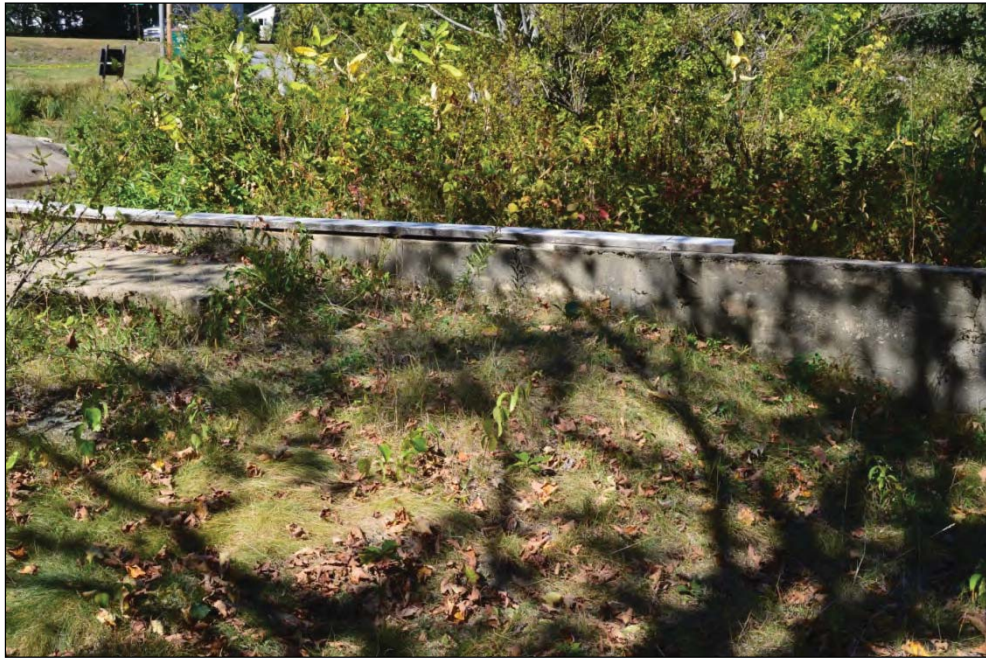
Photo #10 – Overview of the Downstream River

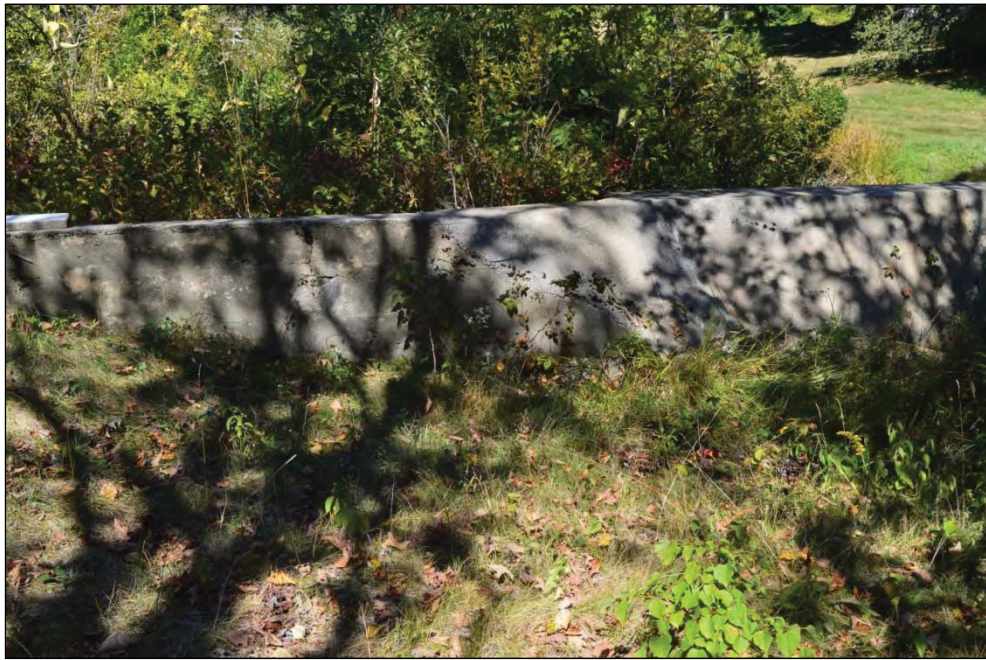
Photo #11 – Left Spillway from Downstream

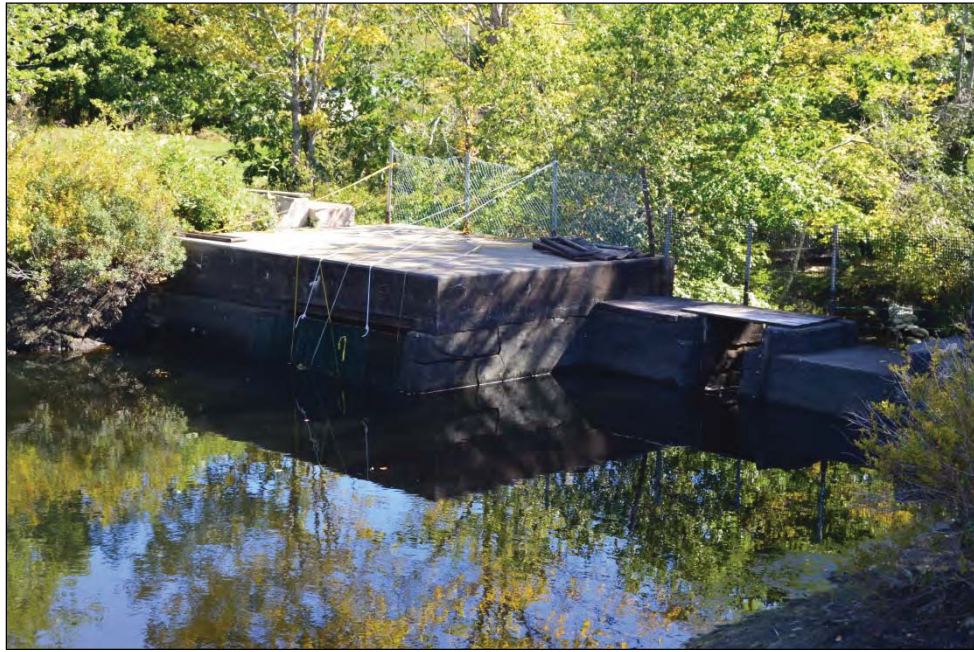
Photo #12 – Left Spillway from Downstream

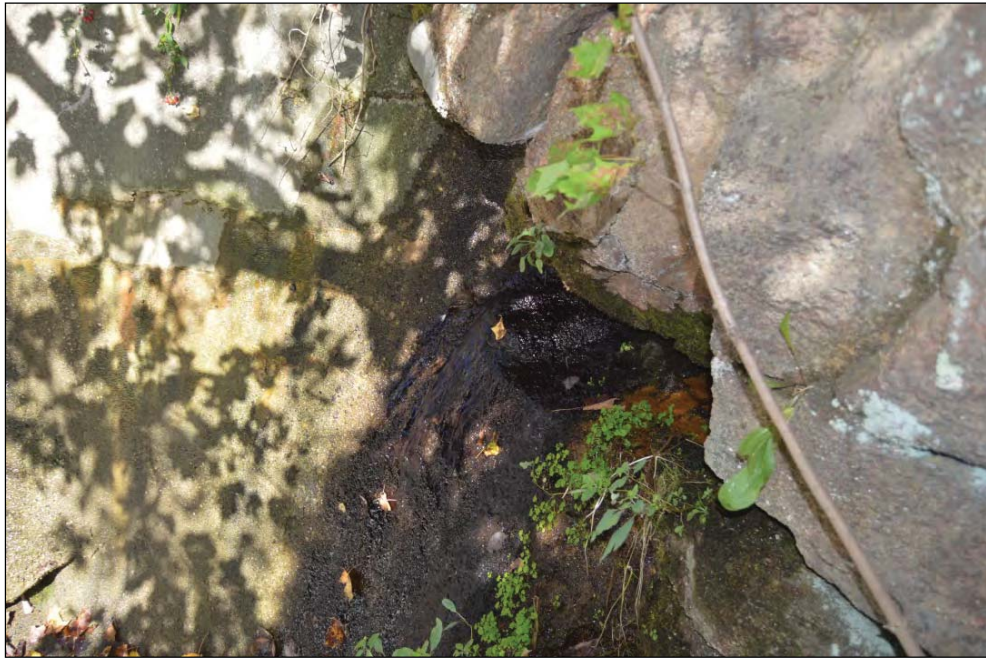
Photo #14 – Downstream View of Former Penstock with Low Level Outfall

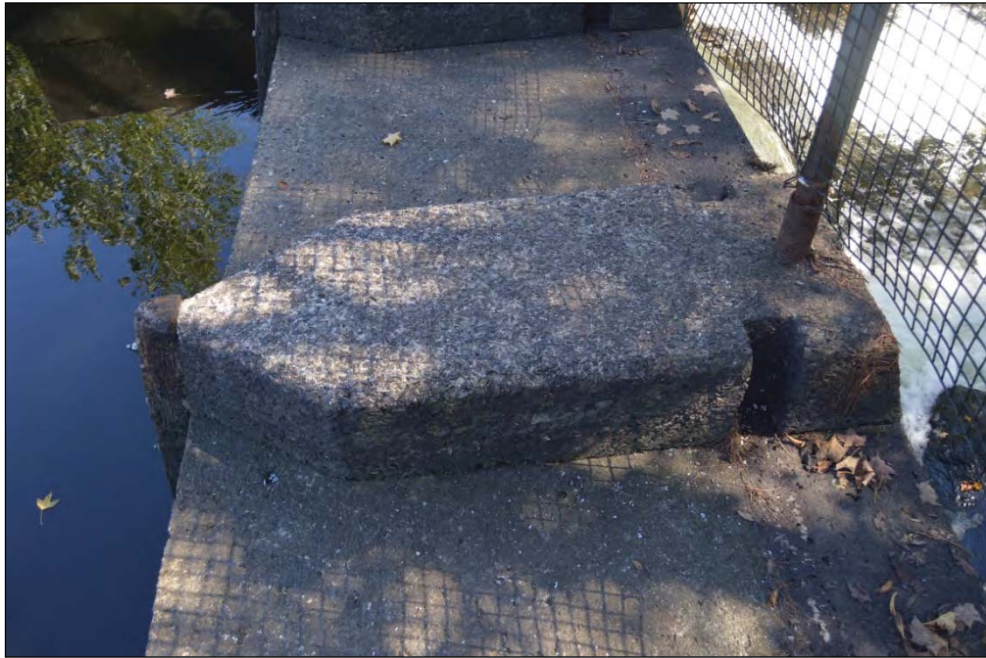
Photo # 17 – Voids at base of Downstream Abutment

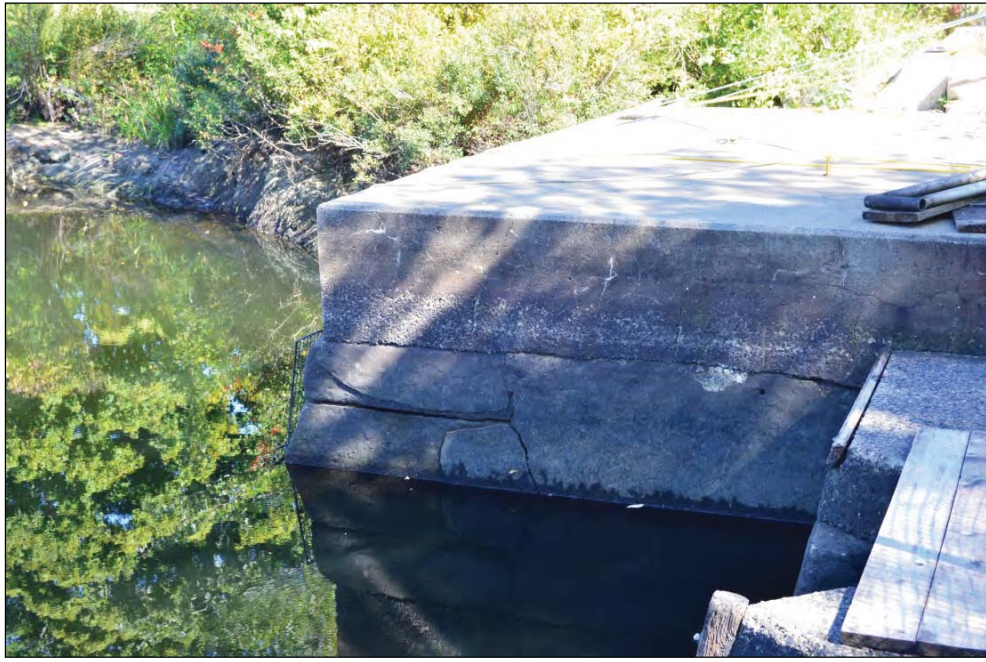
Photo 18 – Minor Concrete Erosion At Spillway Crest
